NRSC

**Northeast Blackout Power Outages
Study Group Report**

March 10, 2004

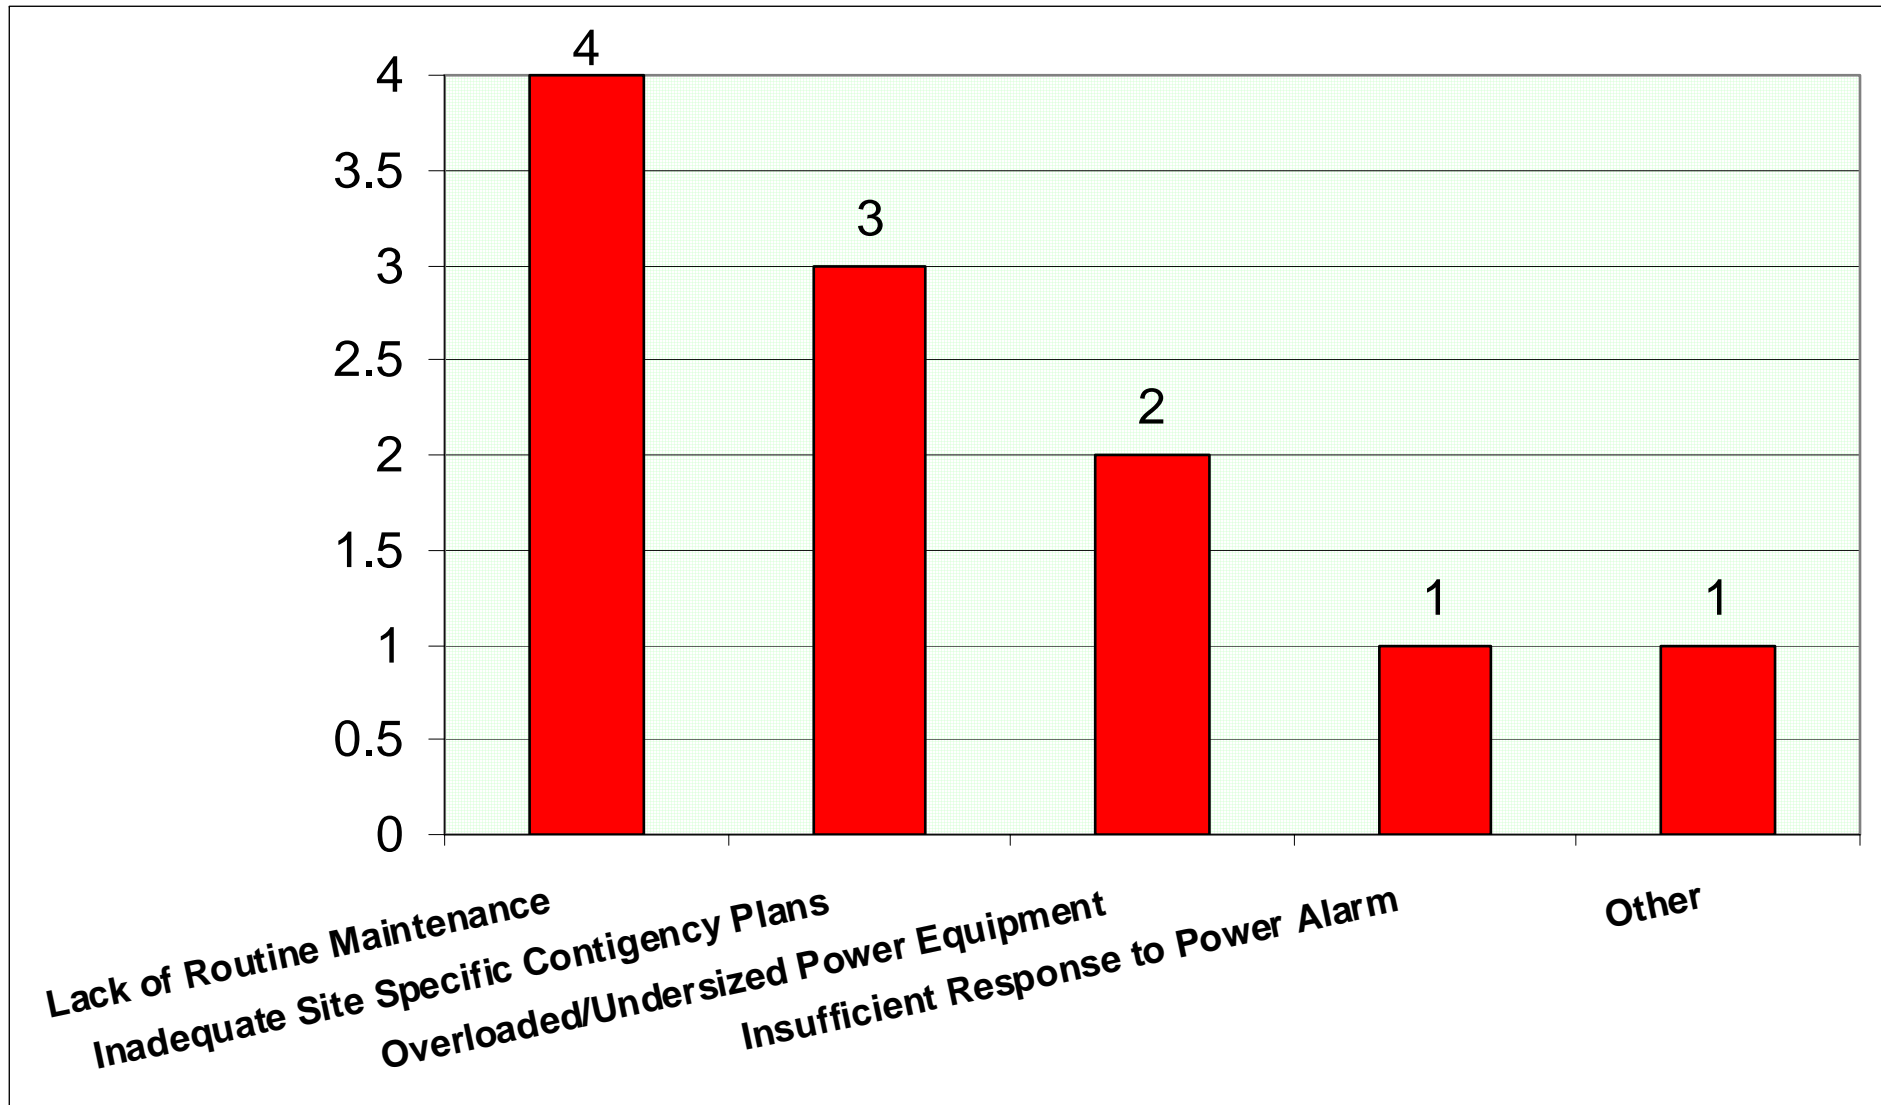
Northeast Blackout Power Outages: Other Contributing Causes: Summary

- **8 Final Reports (affecting 9 buildings)**
 - » One Report covered 11 Switches in 2 building locations
 - Each Switch had different failure conditions
 - » Two Reports were not mandatory under Section 63.100
- **Root Causes**
 - » 5 - Power Failure - extended commercial power failure
 - » 1 – Procedural - Service Provider
 - » 1 - Hardware Failure - Processor community failure
 - » 1 - Hardware Failure - Other
- **Other Contributing Causes (additional study insights)**
 - » 4 – Lack of Routing Maintenance
 - » 3 – Inadequate Site Specific Contingency Plans
 - » 2 - Overloaded/Undersized Power Equipment
 - » 1 - Insufficient Response to Power Alarm
 - » 1 – Other
- **Summary: Substantial guidance gleaned from ‘Other Contributing Causes’**
