NRSC

Timing Outages Task Group - Executive Summary -

March 6, 2002

Timing Outages Task Group Report

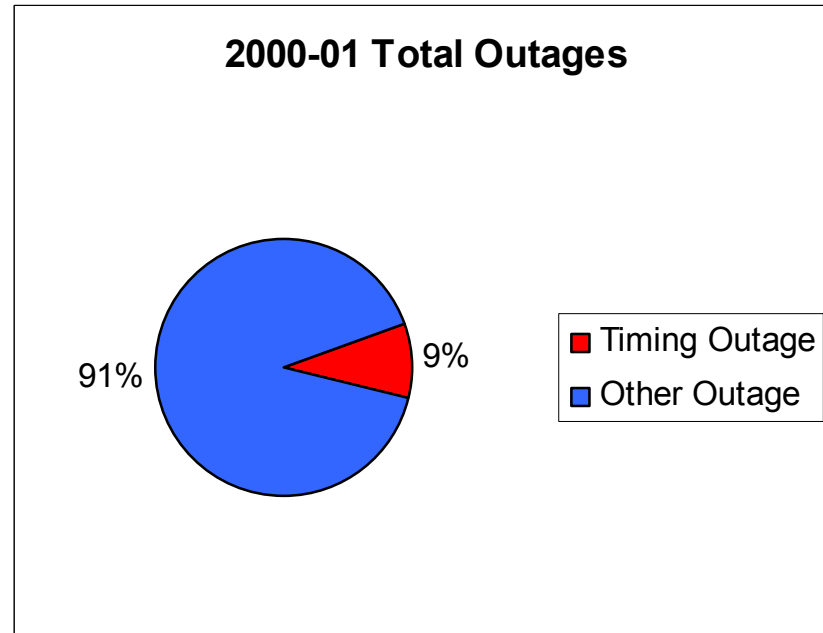
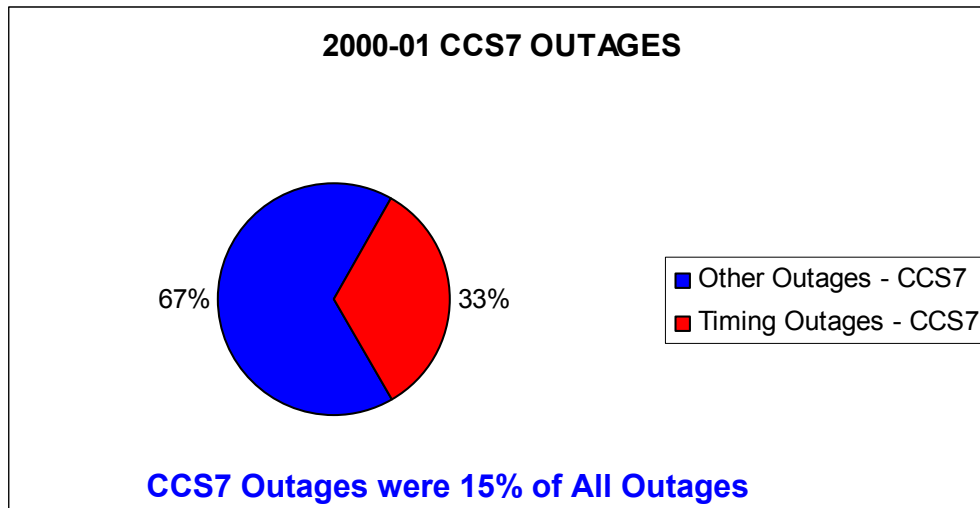
9.4% of all Outages were from Timing Outages

33% of all CCS7 Outages were Timing Outages

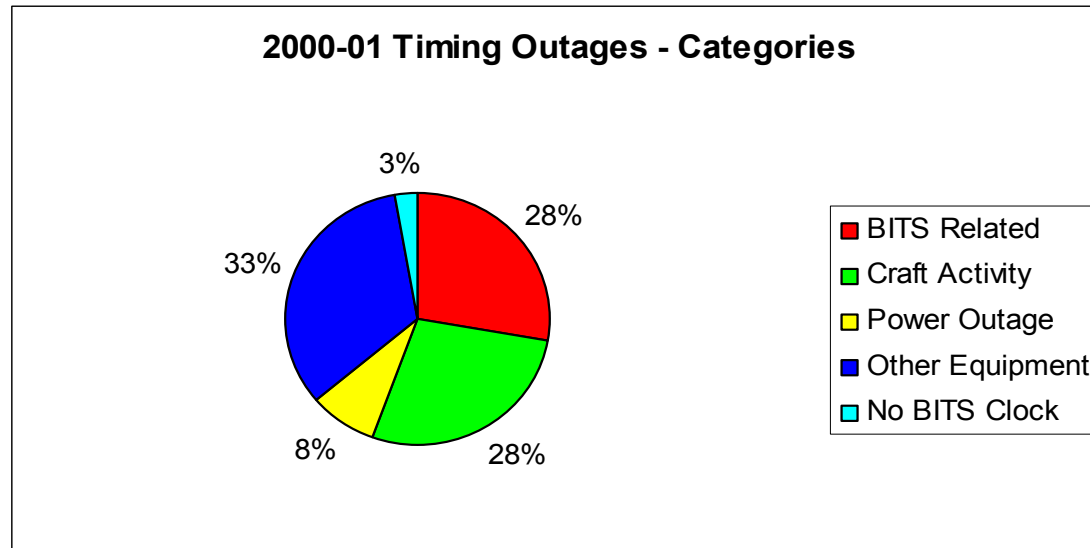
- BITS Failures cause significant number of office outages
 - Many Timing Outages were not reported as 'Alarmed'
 - CCS7 Alarms are often the 1st indication of a BITS Outage
- BITS Related Outages
 - Lack Diverse Links to Redundant 'Timing Output' Cards
 - Failure to switch to Redundant Timing Output Card
 - BITS 'Clock Input' card failure (e.g., Stratum 2 or 3)
- Procedural and Craft Activity Error
 - BITS Upgrades failures
 - Dual BITS Fuse Outage
- Power Failure causing office Timing Outages
- No BITS Clock in Office

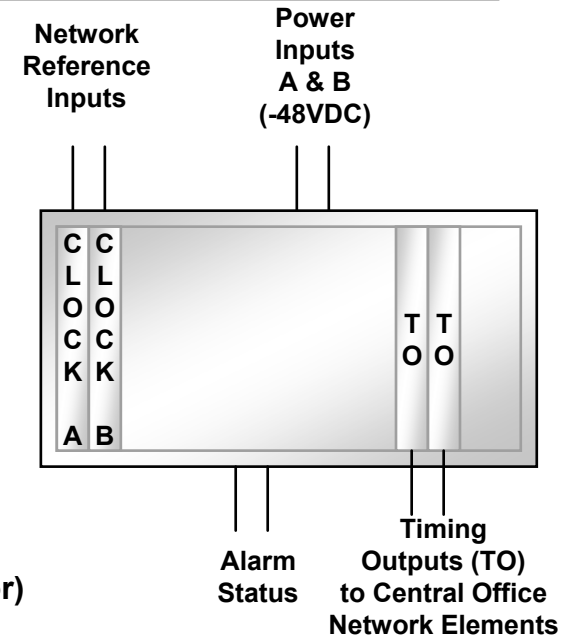
Building Integrated Timing Source (BITS)

- **Stratum 1, 2E, 2, 3**
 - Normal Operation: Clock Reference from Network
 - Stand-Alone Operation: Clock maintains precision (e.g., ST2, ST3)
- **Shelf Powering**

- Full Protect DC Powering (-48VDC) SHOULD BE Required (UPS + Generator)
 - Redundant (A/B) power SHOULD BE required
 - » Note: Duplex Fuse Outage disables BITS clock (equivalent to total power outage)

- **Redundancy**
 - Stratum Clock MUST BE redundant – should ‘fail over’ gracefully and with Alarms
 - Timing Output (TO) cards MUST BE redundant
 - » Redundant Network Element Timing Leads must terminate on separate Timing Output Cards

- » Special diversity strategies may be required to handle unique timing applications
 - Special Office Configuration issues
 - » D4 bays are often supported with a single timing lead. Any redundant facilities (e.g., SS7 links) should terminate on separate D4 shelves with diverse timing leads.

- **Alarming**
 - » Loss of Network Reference, Power, CP Outage, Switch to Redundant Pack, ...

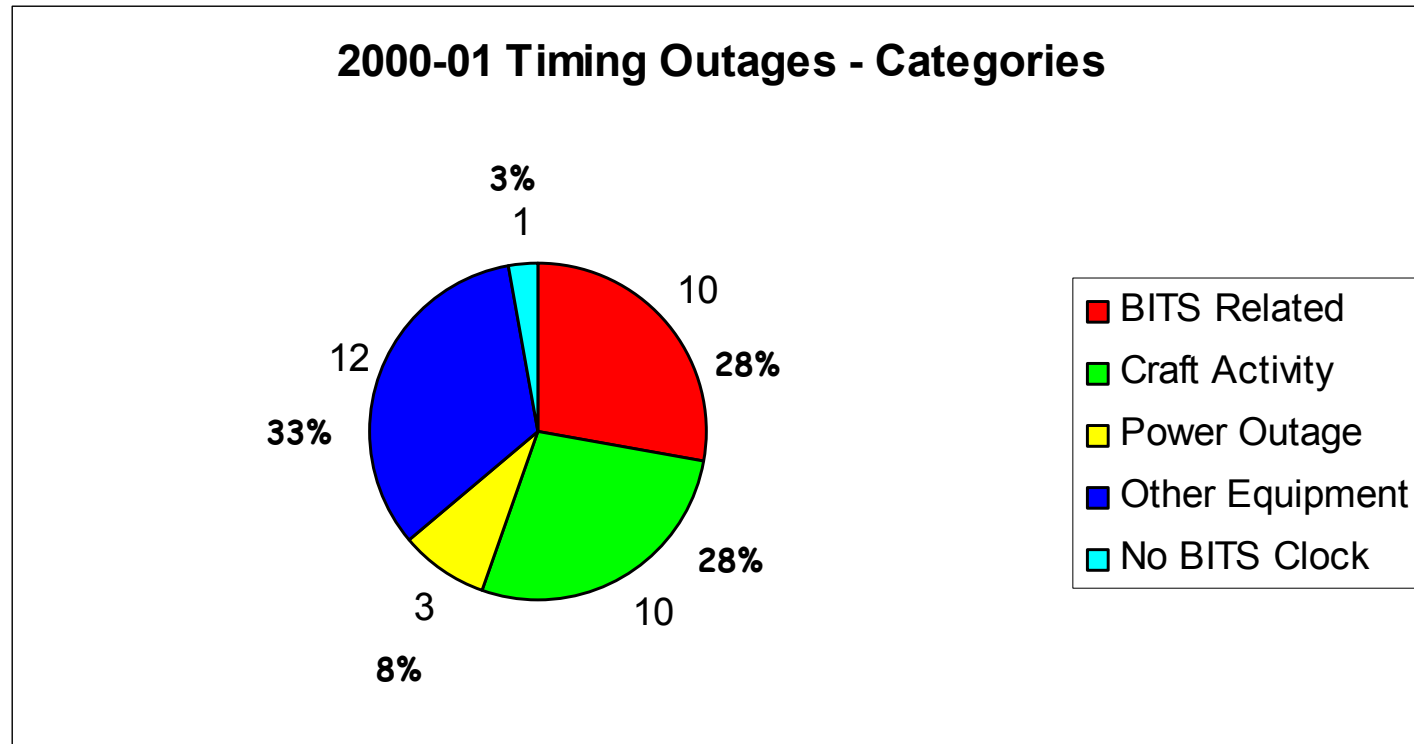
Timing Outages - Summary

- **66% of Timing Outages were the result of**
 - BITS related
 - » Intra-Office Redundancy/Diversity (e.g., facilities, cards, faulty fail-over)
 - Procedural Error by Craft
 - Improper BITS Powering (Commercial and Backup)
- **33% of Timing Outages were from other Network Elements**
 - Unclear if some of these were caused by BITS fail-over problems

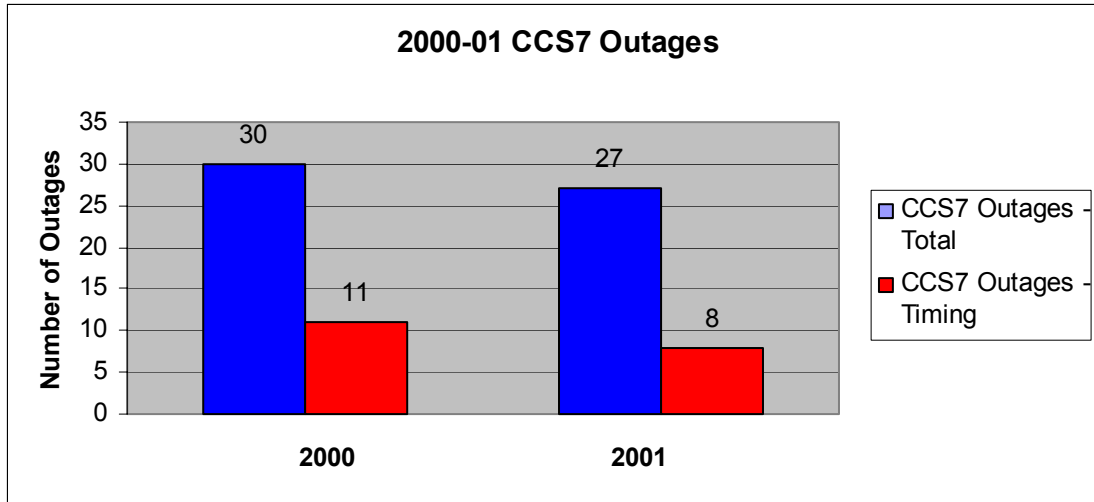
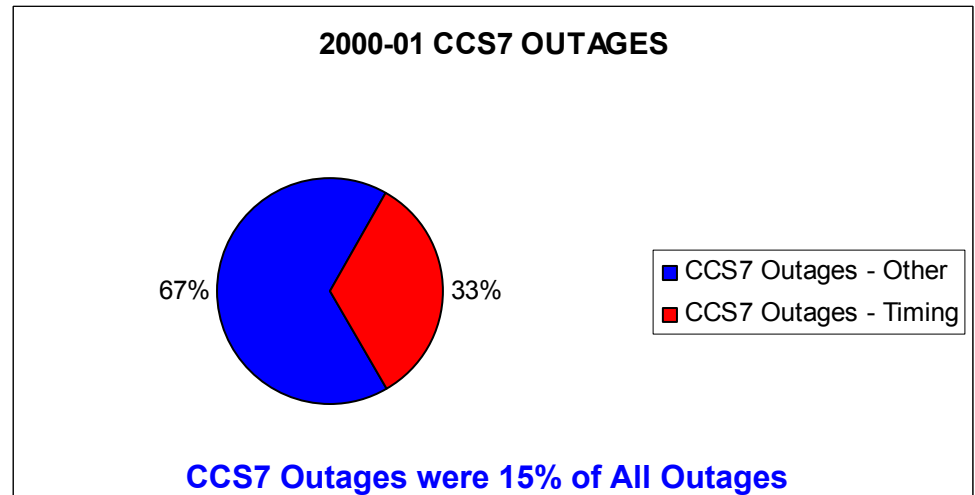
- **57 CCS7 Failures in 2000-01**
- **19 CCS7 Failures caused by Timing Outages**

33% of all CCS7 Outages were caused by Timing Outages

- **14% BITS related**
- **19% Other Timing Outages**

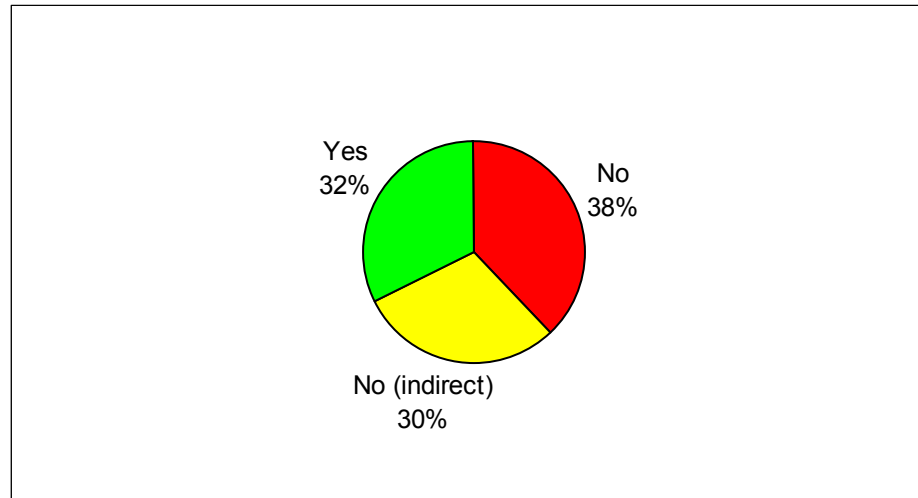
Timing Outages - Alarms

- **Timing Outages/BITS failures are often not alarmed**
- **CCS7 Alarms are often 1st indication of a Timing Outage**

Caution: Alarm conditions are not always clearly stated in outage report

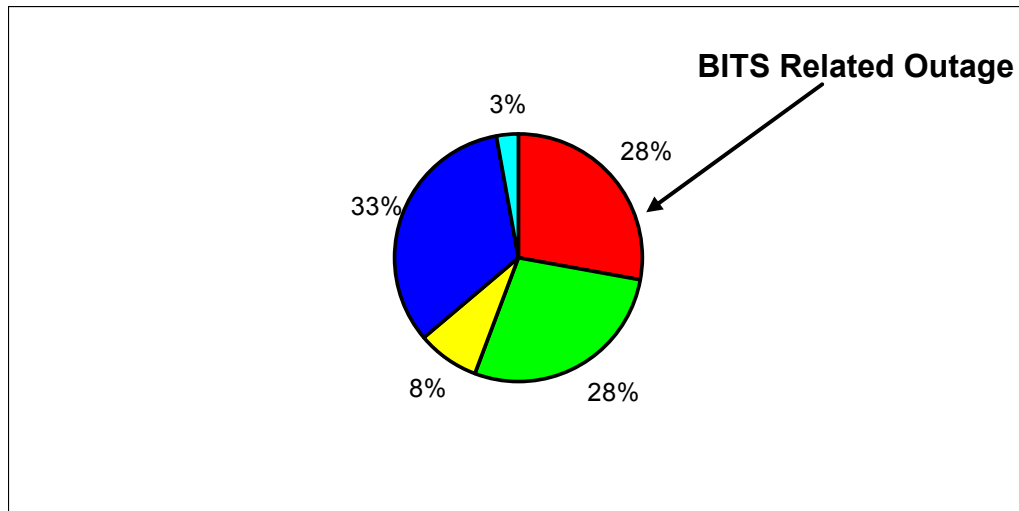
BITS Related Outages

Total	Sub-Total	Outage Category
10		BITS Related
	2	Shelf Clock Card
	2	Failure - Duplex Failure of Primary & Redundant Timing Output Card
	3	Failure - Simplex 'Timing Output' card (with both Timing Links)
	3	Failure - in Switching to Redundant 'Timing Output' card

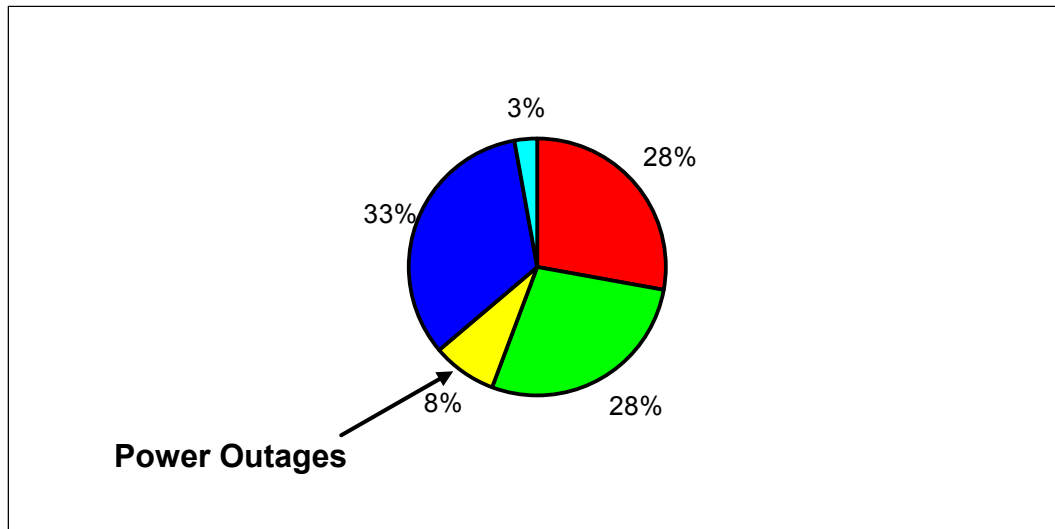
Timing Outages caused by Power Outages

- **POWER FAILURES** causing Timing Outage
 - 8% of all Timing Outages
 - No Backup Power
- **BITS shelf MUST BE on 'Full Protect'**
 - UPS and Generator

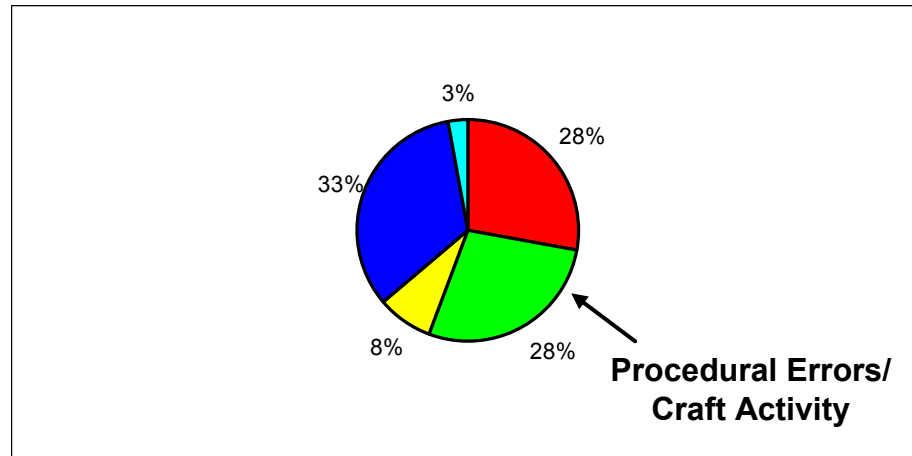
Timing Outages: Procedural Error

- **BITS Shelf upgrade failure**
 - Removing timing leads (wires)
 - Clock Input Card Upgrade (to Stratum 2)
 - BITS enhancement (adding dual power feeds)
- **Dual BITS shelf fuse outage**
 - Clearing Rack Space -> Power outage (Fuses)
 - Shorting backplane causing Duplex Fuse Outage
 - » Plastic protective shield was removed
- **Faulty Method Of Procedure (MOP)**
 - BITS Shelf Replacement
 - Lack of Training/Supervision
- **Installation of New Equipment (non-BITS) – Indirect Cause**
 - Installation of fuse panel, power supply & cable removal
- **Other craft activity**
 - Disabling BITS backplane pins
